~~LEVEL II~~  
**FLOOD PLAIN  
INFORMATION**

**CRUM CREEK  
DELAWARE COUNTY  
PENNSYLVANIA**

**PREPARED FOR THE DELAWARE COUNTY PLANNING COMMISSION  
BY THE DEPT. OF THE ARMY, PHILADELPHIA DISTRICT, CORPS OF  
ENGINEERS, PHILADELPHIA, PA.**

**MARCH 1974**

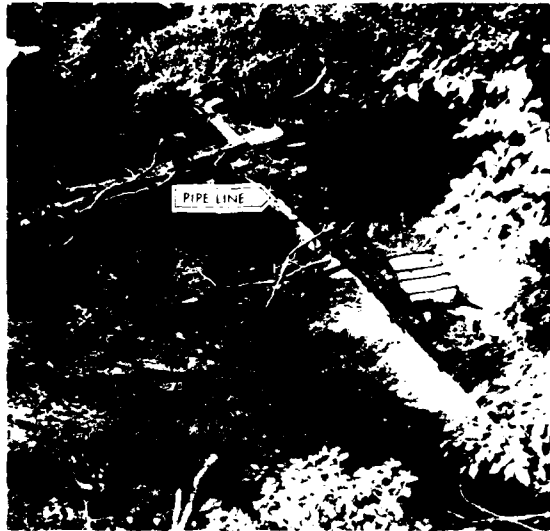
**FIGURE 1** - Accumulated debris at a pipe line crossing Crum Creek upstream of MacDade Boulevard.

In general, obstructions restrict floodflows and result in overbank flows and unpredictable areas of flooding; destruction of or damage to bridges and culverts; and, an increased velocity of flow immediately downstream. It is impossible to predict the degree or location of the accumulation of debris; therefore, for the purposes of this report, it was necessary to assume that there would be no accumulation of debris to clog any of the bridge or culvert openings in the development of the flood profiles. Representative photographs of obstructions to floodflows may be seen in Figures 1 through 3.

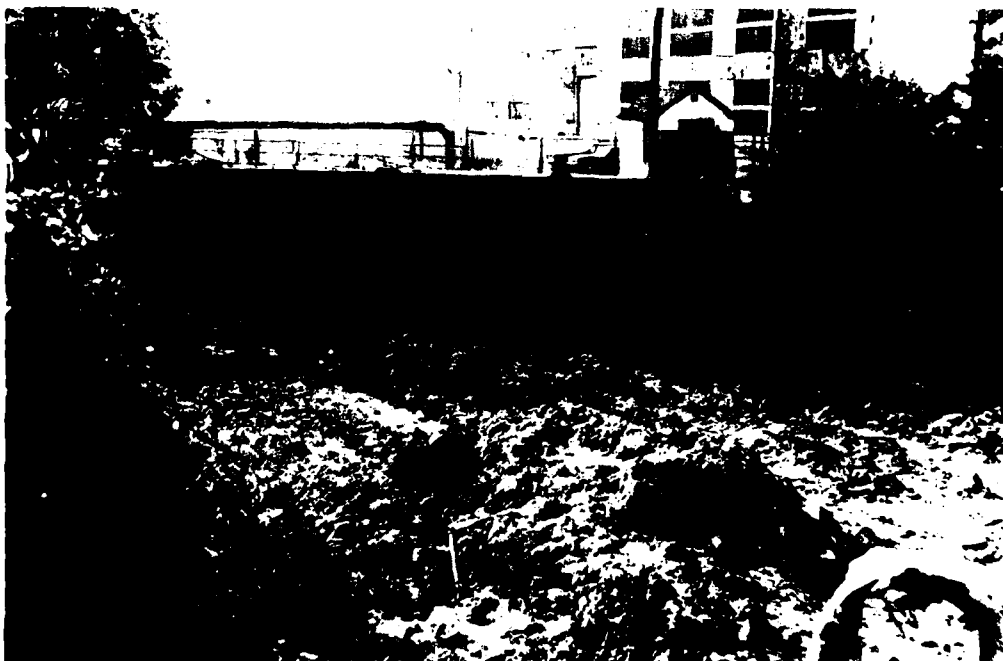
**FIGURE 3** - Chester Pike, U. S. Route 13, bridge is obstructive to the flow of Crum Creek.

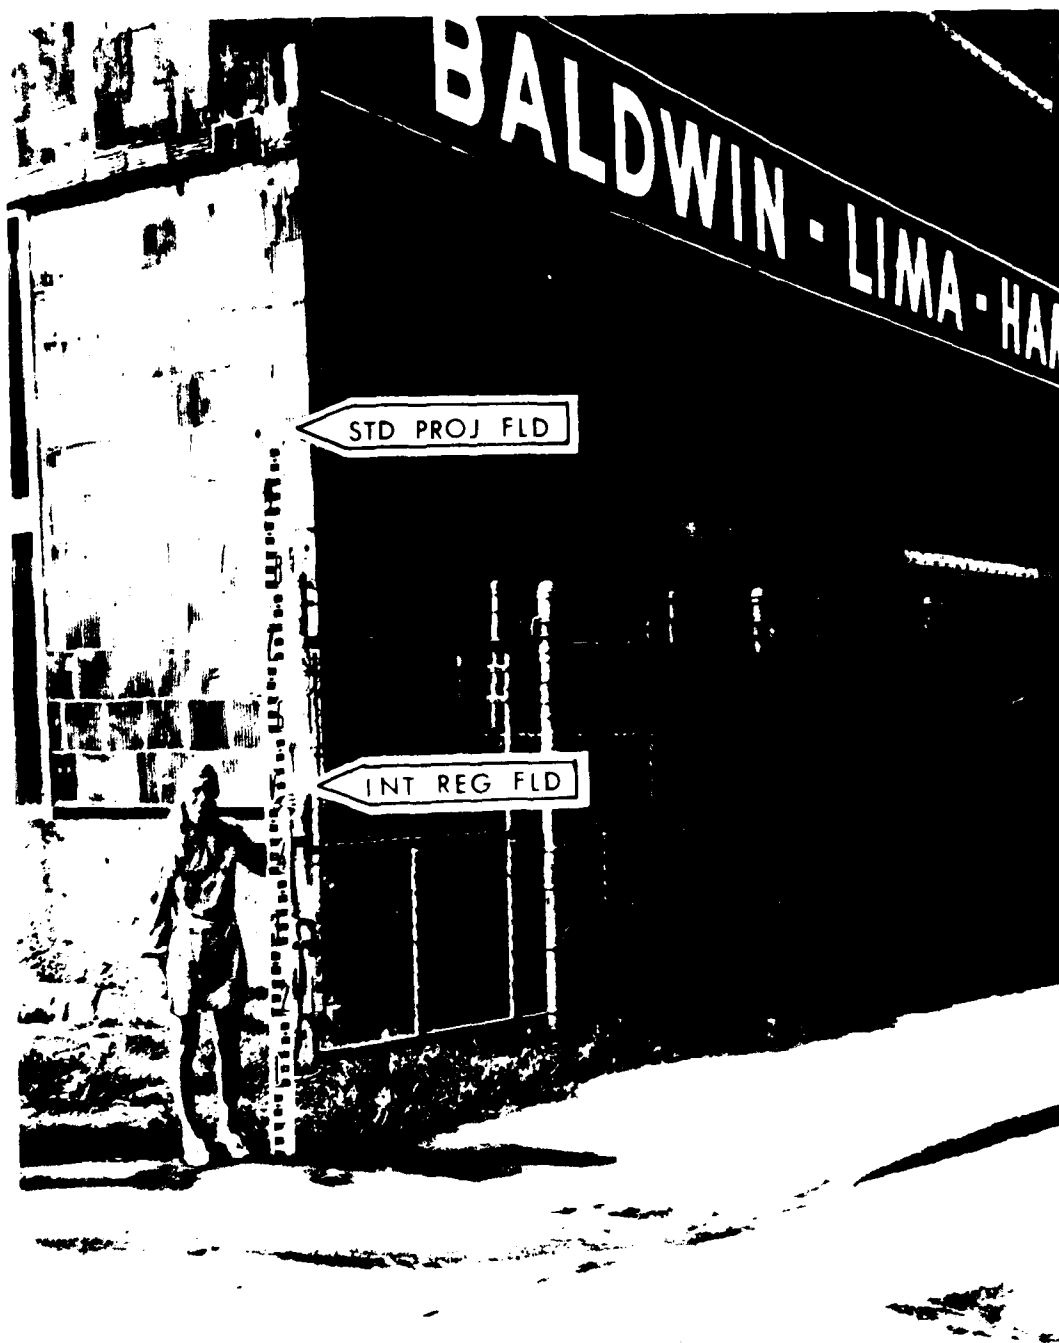
FIGURE 4 - Future flood heights of Crum Creek at a Baldwin-Lima-Hamilton Corporation Plant on Chester Pike, U. S. Route 13.

**Photographs, future flood heights** - The levels that the Intermediate Regional and Standard Project Floods are expected to reach, and heights reached by some past floods at various locations in the Crum Creek study area are indicated on the following photographs.

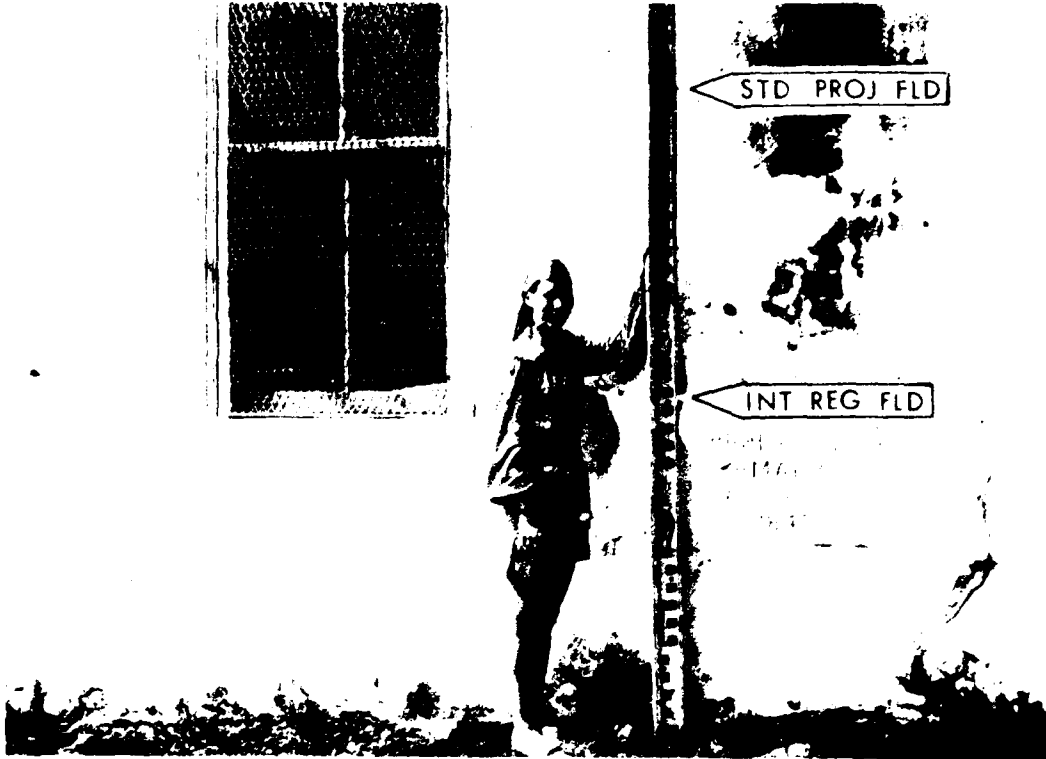
FIGURE 5 - Flood heights at the Philadelphia Suburban Water Works.

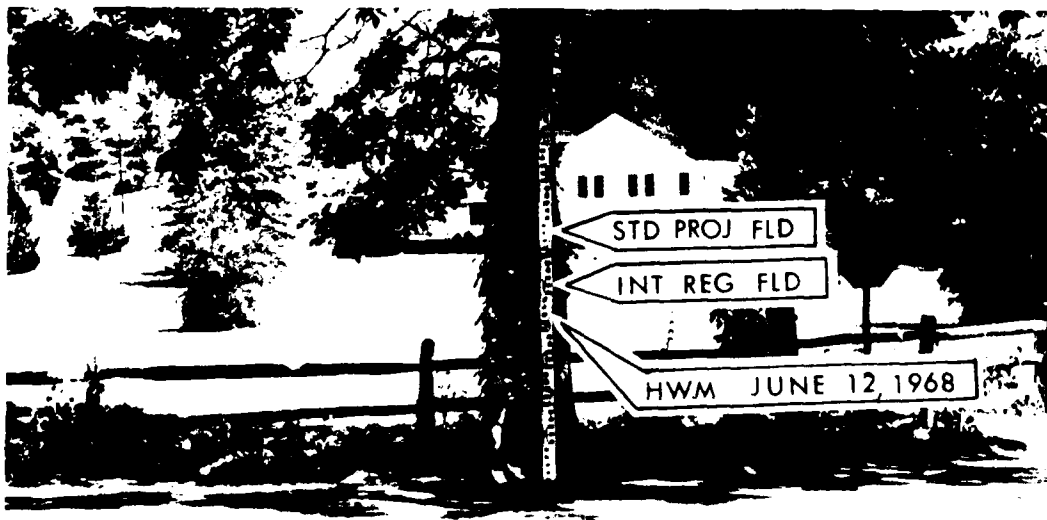
FIGURE 6 - Flood heights near the intersection of Boot and Goshen Roads.

June 12, 1968 - Heavy rainfall over the upper Crum Creek Watershed caused local flooding on Boot Road near Goshen Road. Debris in the channel caused the stream to back up covering Boot Road with water to a depth of several feet. There is no specific flood information from Crum Creek on this date but a high water mark was recorded on Boot Road near Goshen Road. (See Figure 6, Page 20).

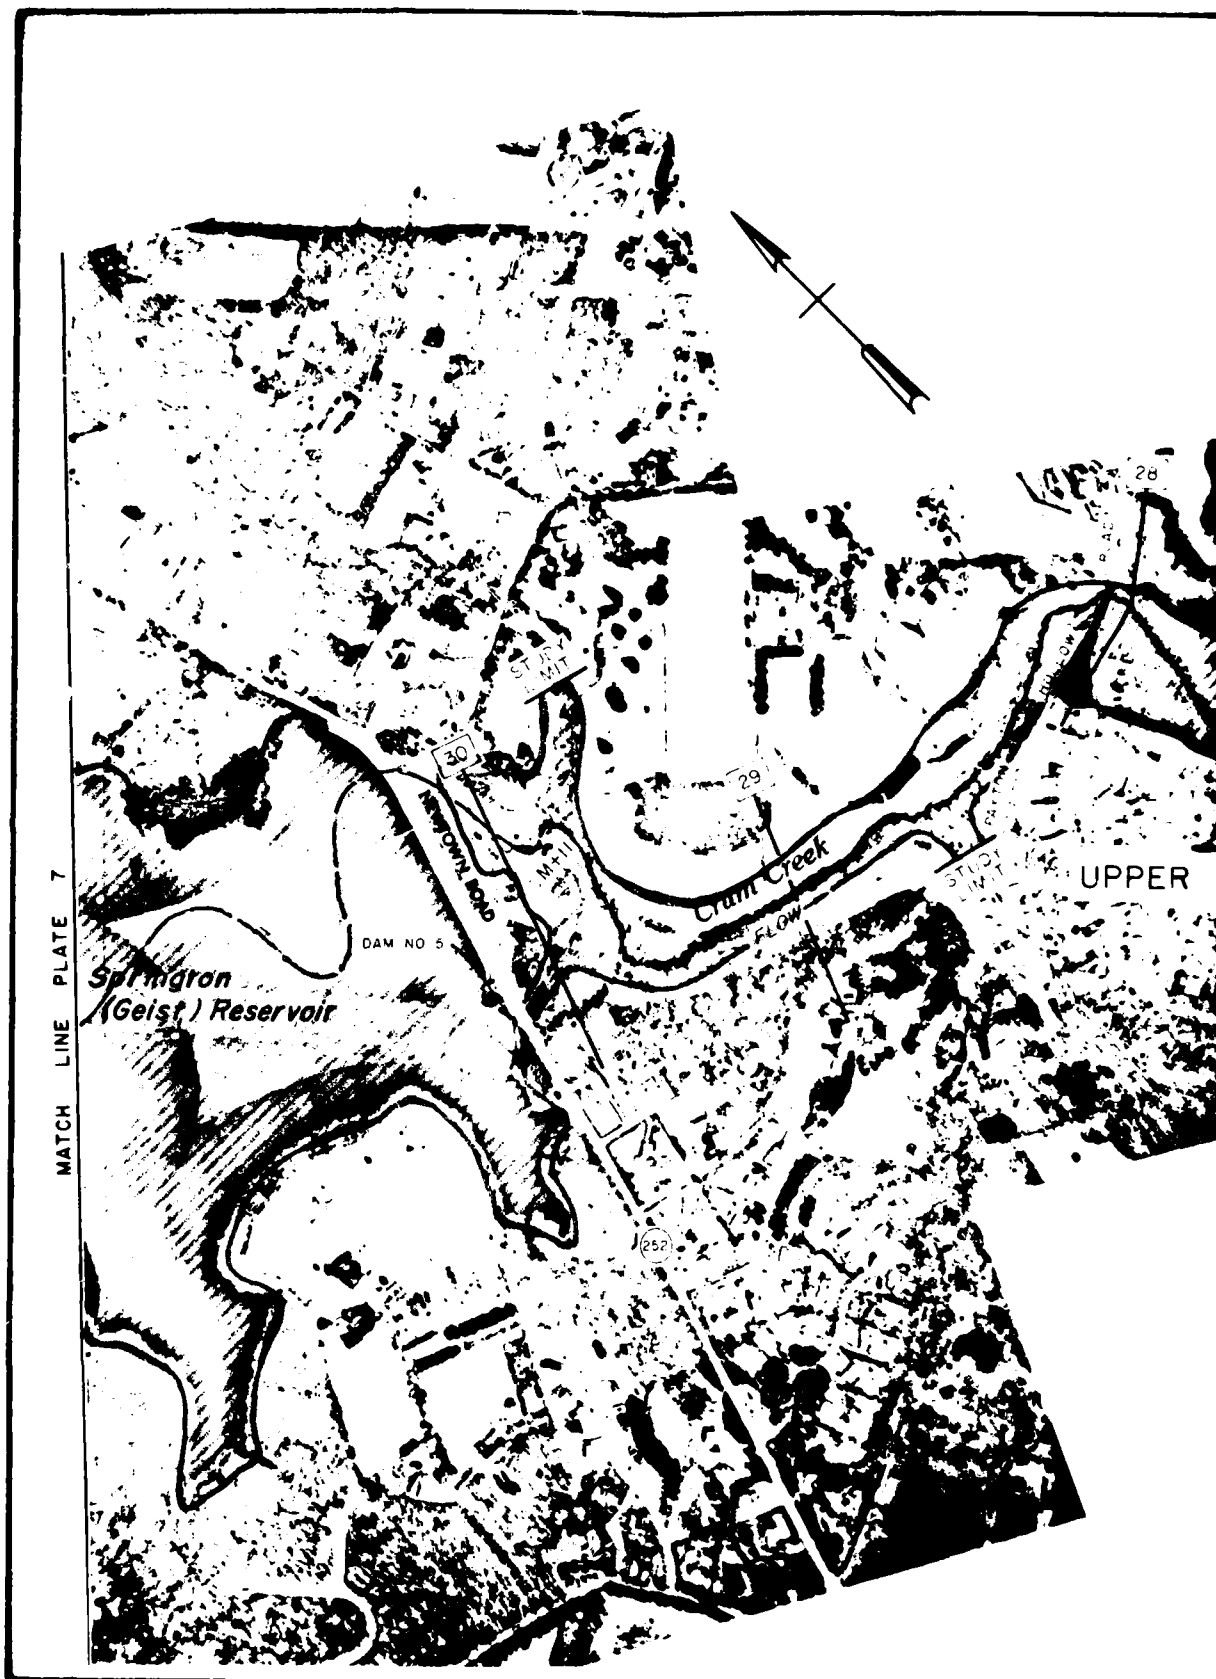
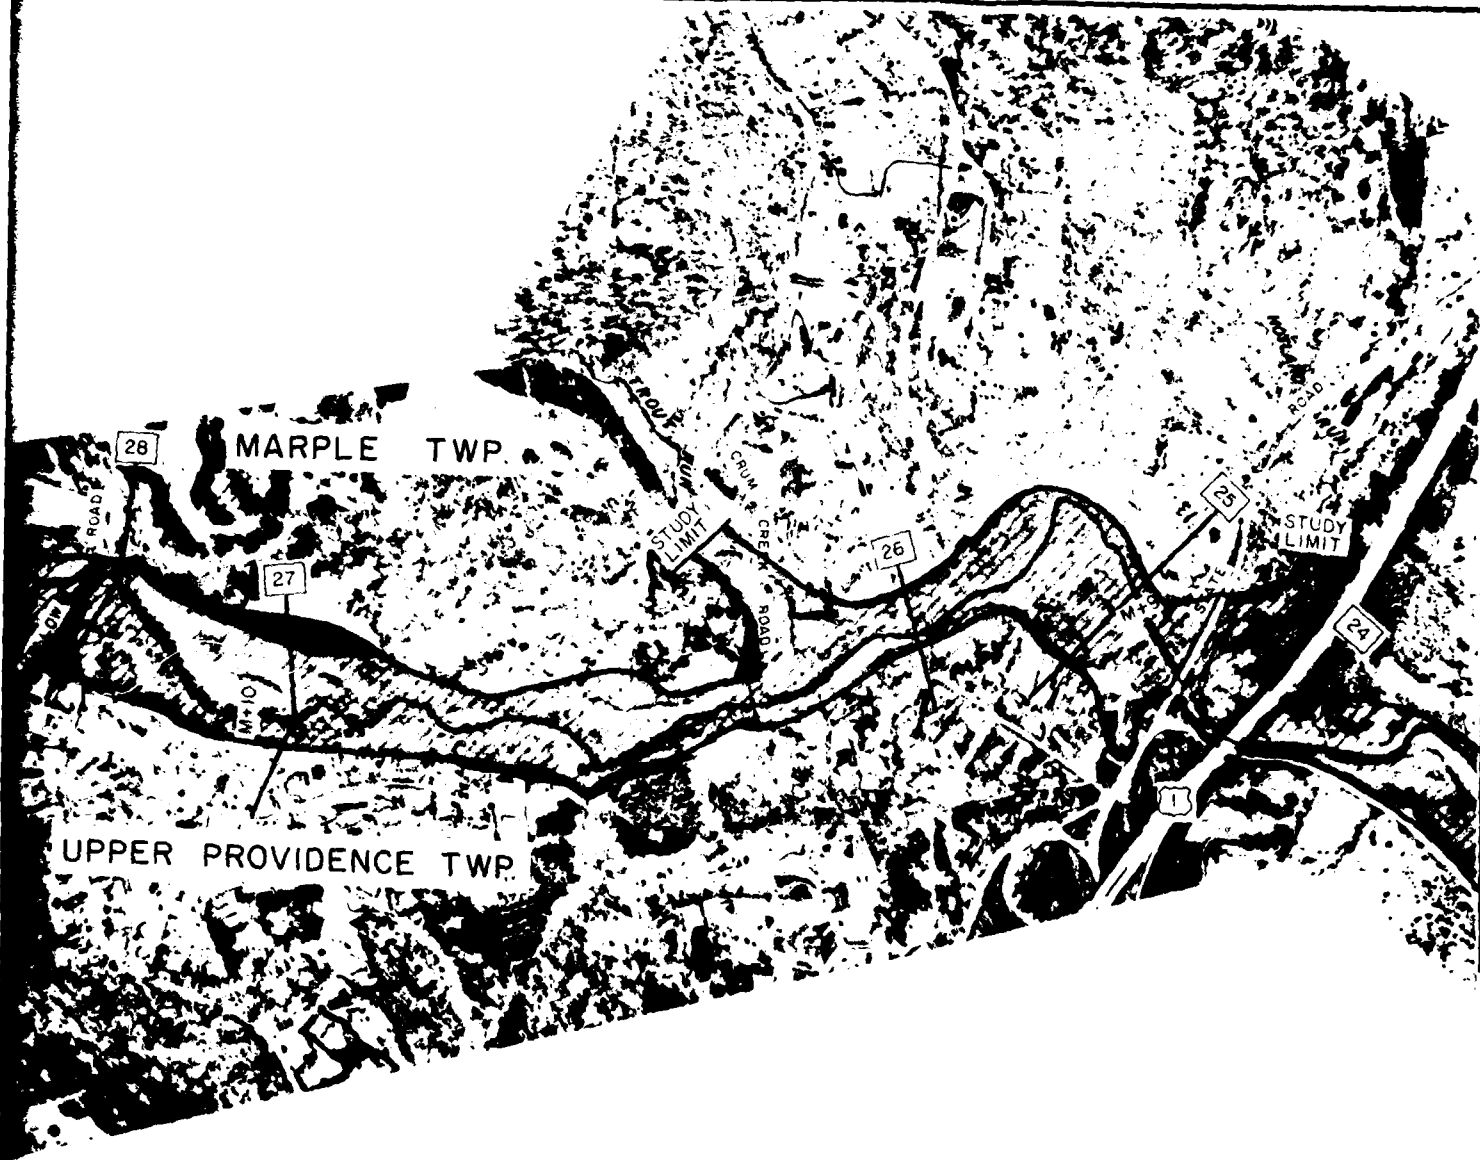
PLATE 5

DEPARTMENT OF THE ARMY  
PHILADELPHIA DISTRICT, CORPS OF ENGINEERS  
PHILADELPHIA, PENNSYLVANIA  
FLOOD PLAIN INFORMATION  
CRUM CREEK  
DELAWARE COUNTY, PA.  
FLOODED AREAS

**Flooded areas and flood damages** - The areas along the study reach of Crum Creek that would be flooded by the Standard Project Flood are shown on Plate 2 which is also an index map to Plates 3 through 8. Areas that would be flooded by the Intermediate Regional Flood and the Standard Project Flood are shown in detail on Plates 3 through 8. The actual limits of these overflow areas may vary somewhat from those shown on the maps because the scale of the maps does not permit precise plotting of the flooded area boundaries. As may be seen from these plates, floodflows from Crum Creek would inundate portions of many communities adjacent to the stream.

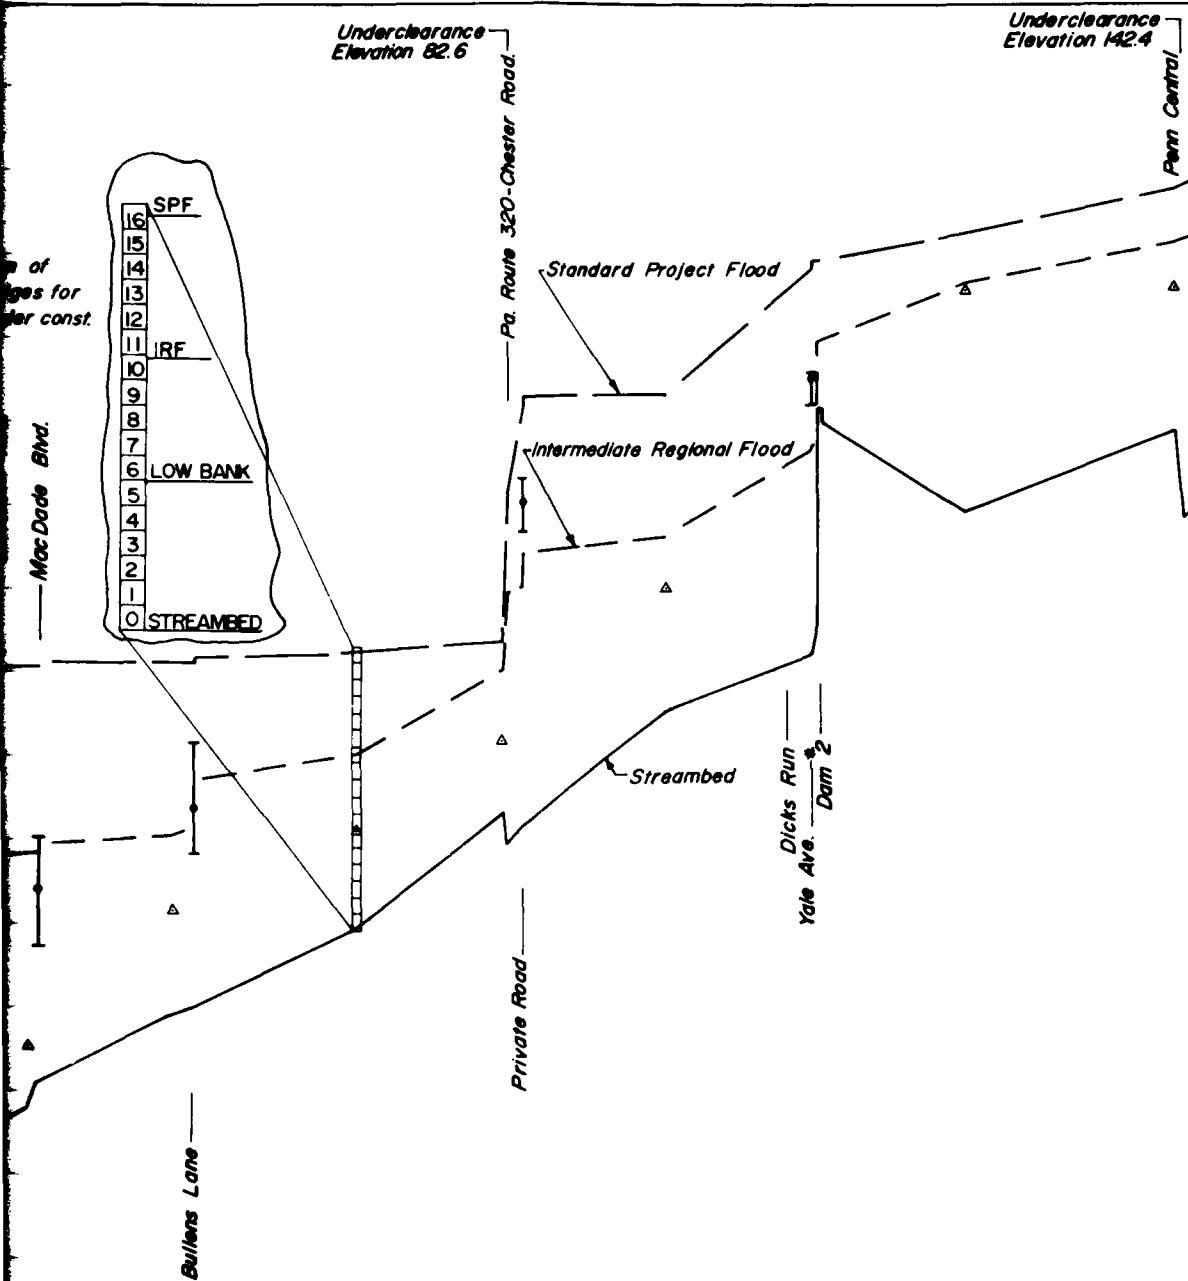
PLATE 9

- Top of Bridge Railing
- Bridge Floor
- Underclearance
- Top of Rail (R.R. Bridge)
- Top of Low Bank

THE ARMY  
CORPS OF ENGINEERS  
PENNSYLVANIA  
INFORMATION  
CREEK  
COUNTY, PA.  
PROFILES

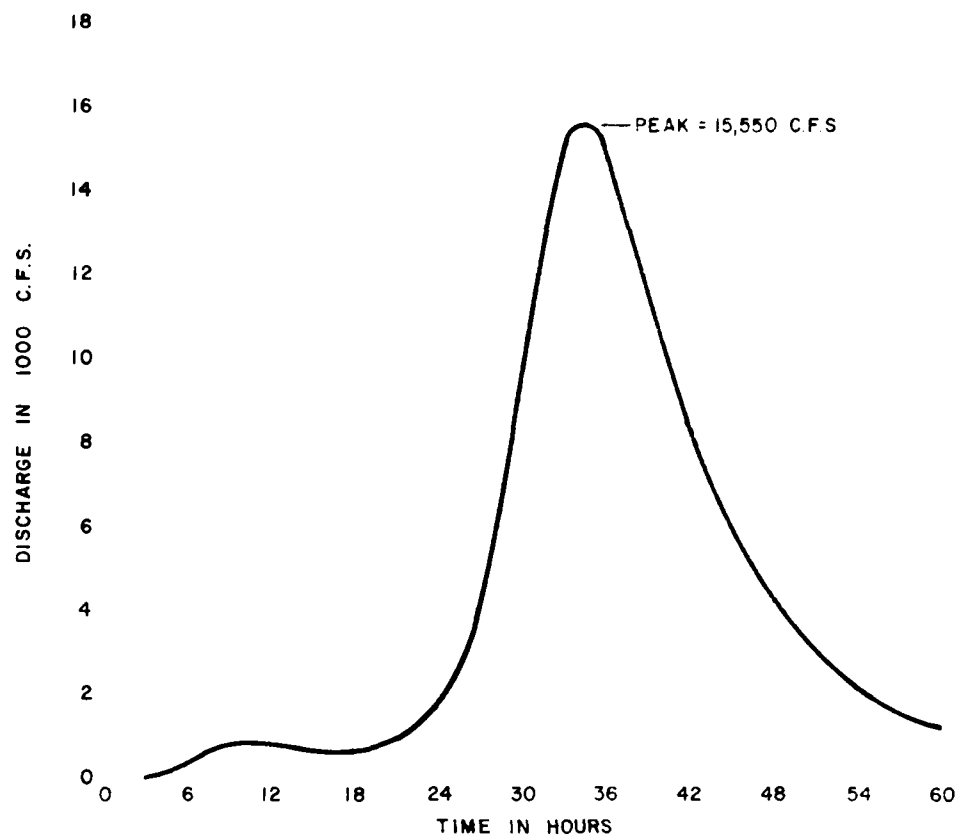
HYDROGRAPH IS TAKEN AT THE  
MOUTH OF CRUM CREEK.  
DRAINAGE AREA = 38.4 SQ. MI.
